RE: **LaMer - Wall**
ECS Job # **56:1622**

Permits:
Location: **3255 S. Atlantic Avenue**
Daytona Beach Shores, FL 32118

FIELD REPORT

Project **LaMer - Wall**
 Location **Daytona Beach Shores, FL**
 Client **Spec Contractor Services, LLC**
 Contractor **None Listed**

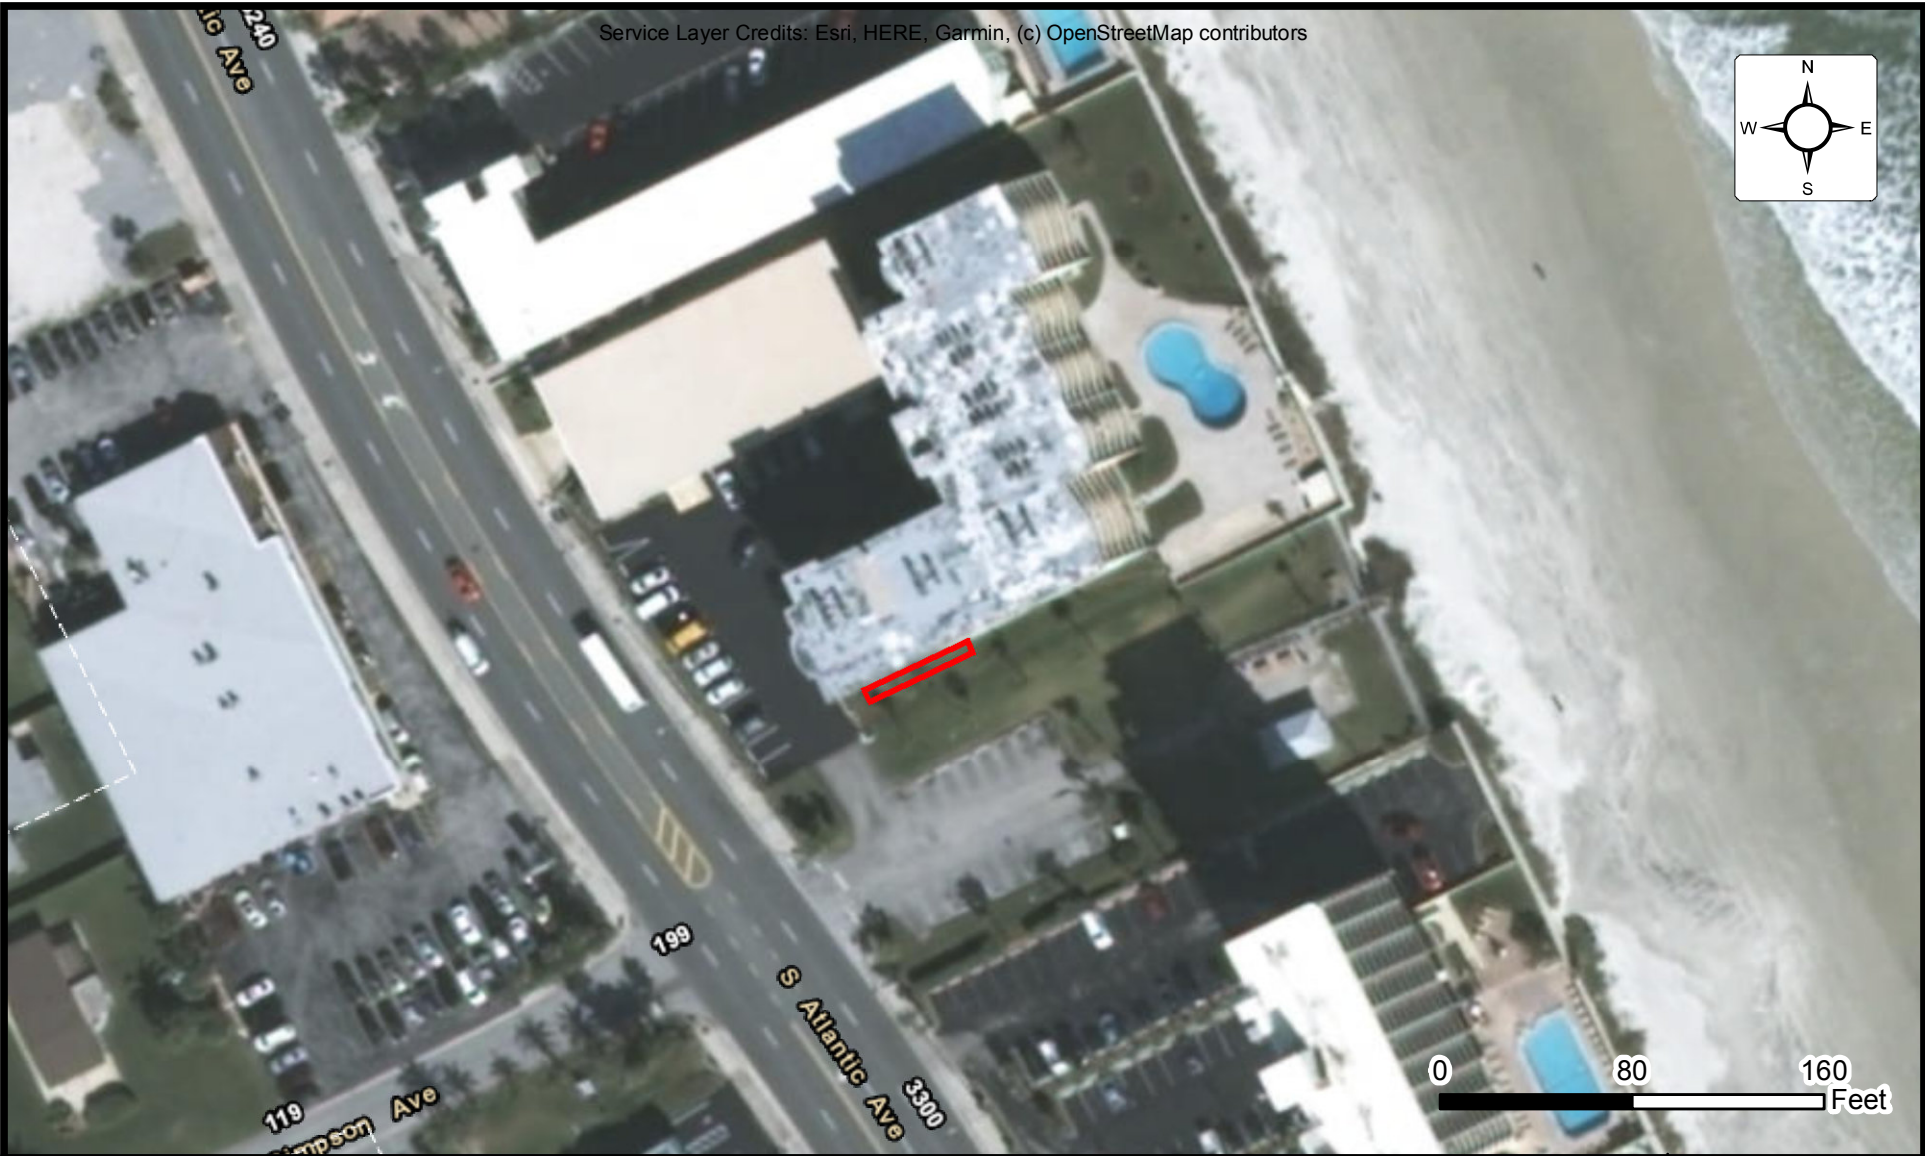
SITE LOCATION DIAGRAM LA MER - WALL

3255 S. ATLANTIC AVENUE, DAYTONA BEACH SHORES, FLORIDA
SPEC CONTRACTOR SERVICES, LLC

ENGINEER DS05
SCALE AS NOTED
PROJECT NO. 56:1622
FIGURE 1 OF 1
DATE 8/23/2022
